Saskatchewan Heritage Foundation  
CONSERVATION BULLETIN SERIES

# Window

**Window** - This Conservation Bulletin is a resource guide for some of the most common issues surrounding wood windows found in Saskatchewan heritage structures. It provides factual information to anyone considering replacing repairable wooden windows.

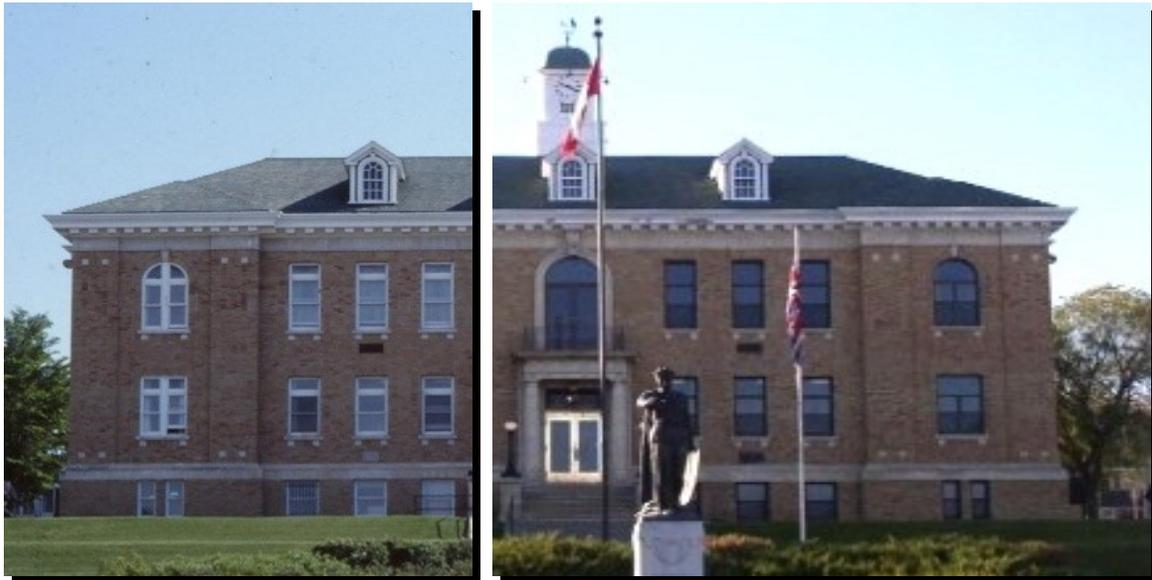
***Court House, Prince Albert SK. - shown with the original white-framed wood windows (left) and the replacement black aluminum sealed units (right). Neither the colour nor the new window design replicates the original, thereby giving the building a very sombre appearance.***

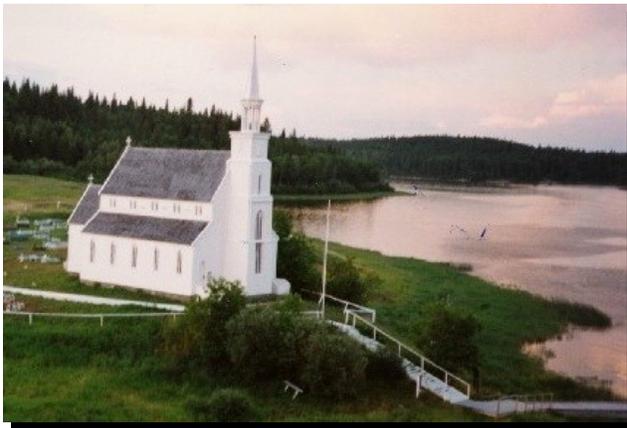
***Holy Trinity Anglican Church, Stanley Mission SK.***  
Government of Saskatchewan Website

*Saskatchewan's oldest building (1854 to 1860), Holy Trinity is a Canadian national treasure. Glass for its Gothic-style windows was brought to this site by boat from England. Now over 150 years old, the maintained windows are still in service.*

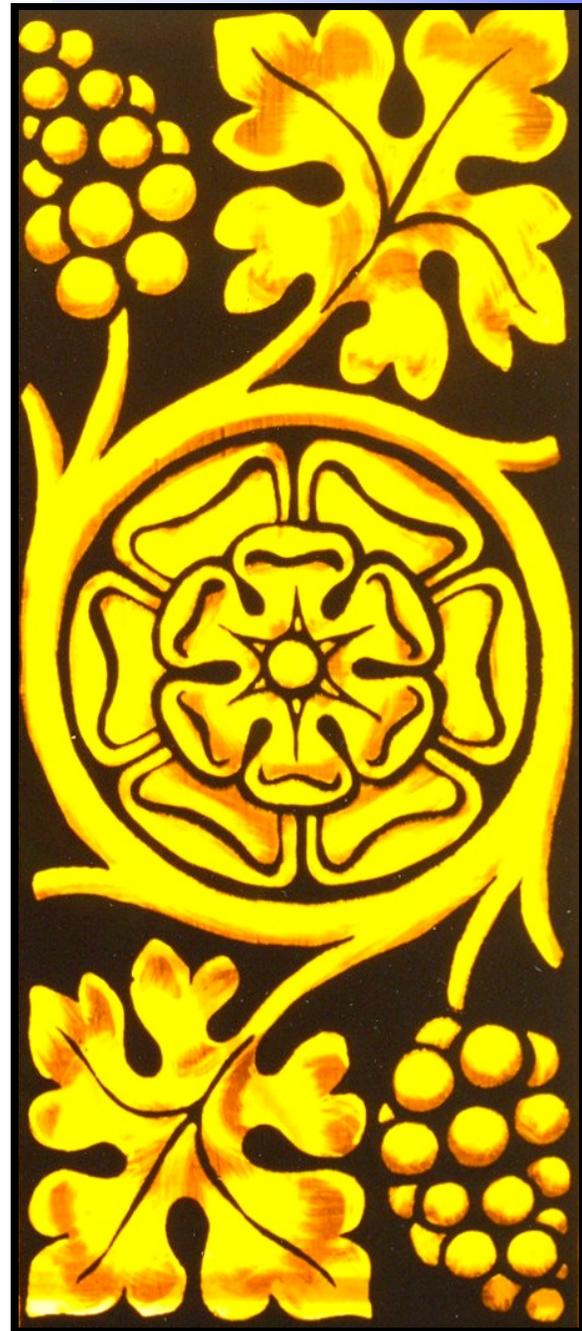
*Holy Trinity Anglican Church, Stanley Mission - Close-up of window pane. / Zelmer*

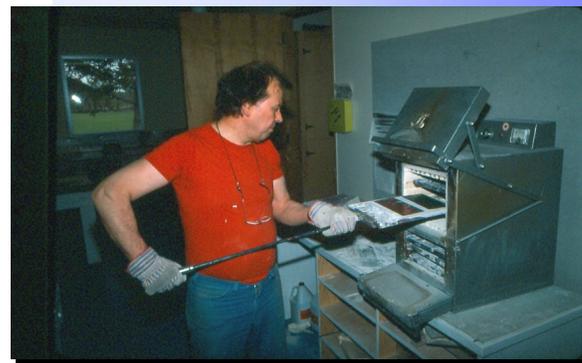
*Neil Balkwill Centre, Regina / Zelmer*

*Award-winning stained glass artist David Johnson places replica window panes into a kiln, prior to their installation in Holy Trinity Church.*

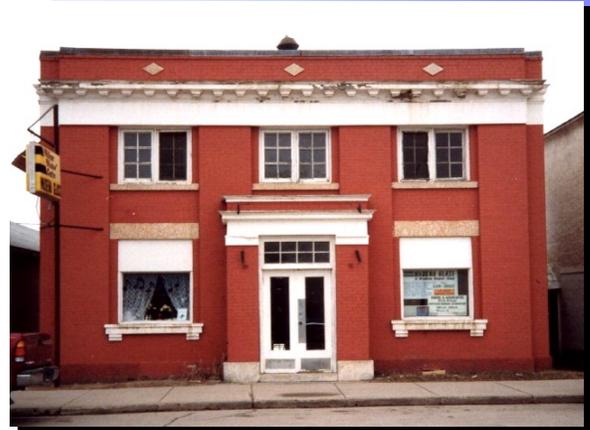
***Commercial Building, Wadena SK***

*The ground floor of many historic commercial buildings was often renovated in the mid-20<sup>th</sup> century, resulting in the installation of new windows inappropriate to the original design.*

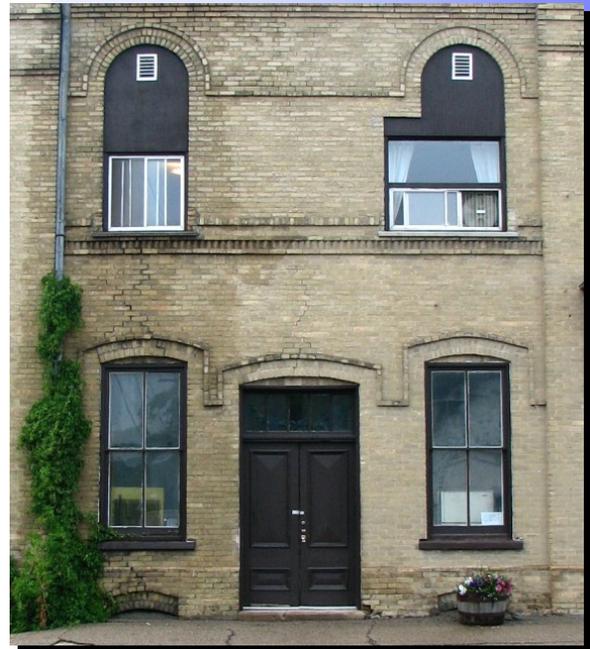
***Commercial Building, Moosomin SK***

*While the original lower floor wood windows remain intact, the upper floor renovations do not respect the historic design.*

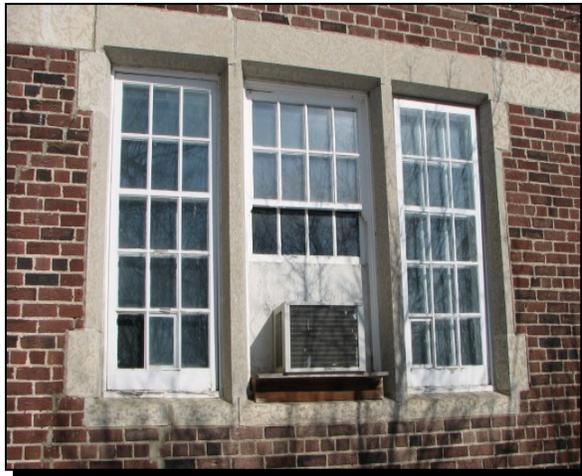
*Diocese of Qu'Appelle complex, Regina SK  
Original storm windows feature numerous individual panes.*

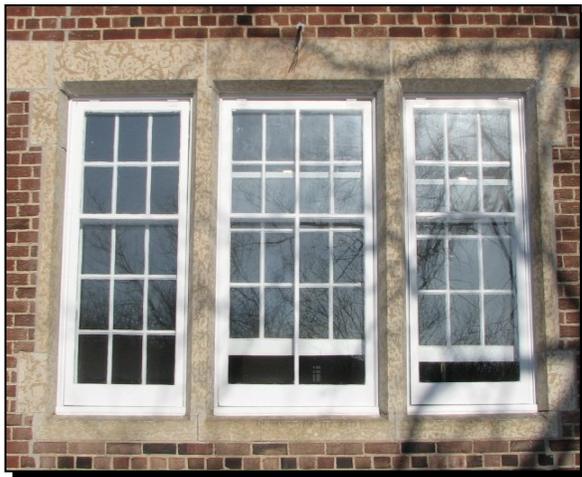
*Diocese of Qu'Appelle complex, Regina SK  
Top-hung wood storm windows are acceptable. They protect historic multi-paned double-hung windows and can open.*

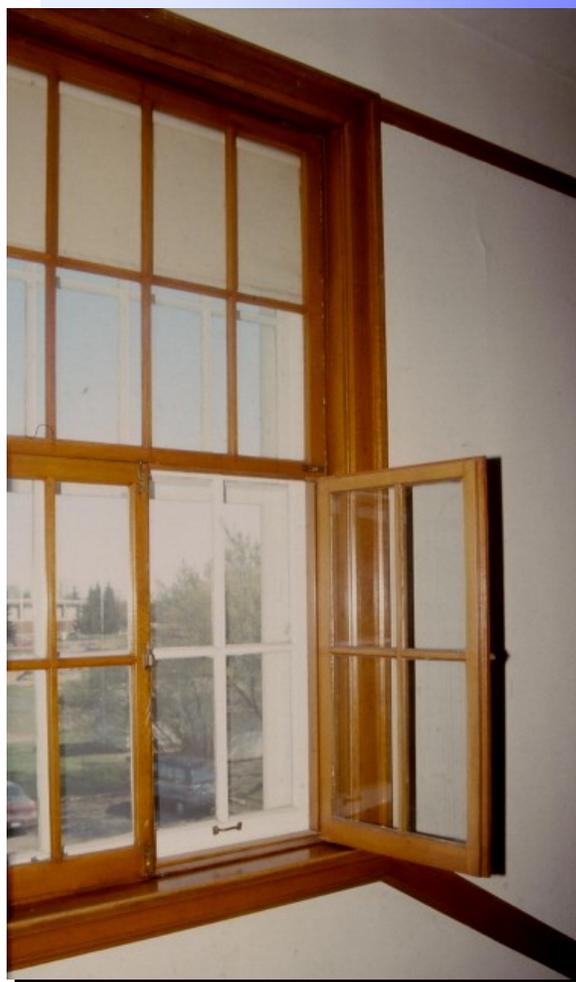
***Court House, Weyburn SK***

*Opening the Court House's casement window provides access to the double-hung primary window.*

Interior casements have existed in the Weyburn Court House for over eighty years. Properly installed and maintained, they help to reduce drafts, reduce heat loss in the winter, improve energy conservation, and enable the introduction of fresh air on an as-needed basis.

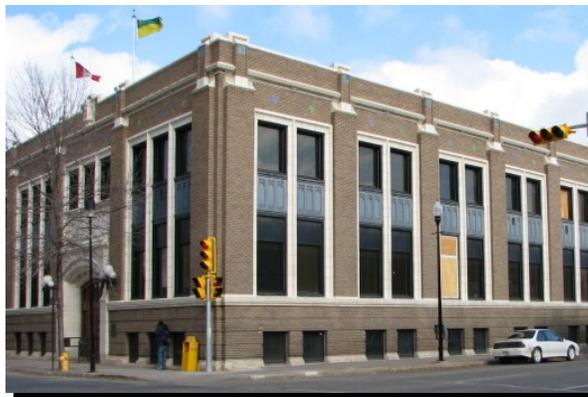
***Sask Revenue Building, Regina SK***

*The windows have been replaced several times since the original 1912 units were removed in the 1960s.*

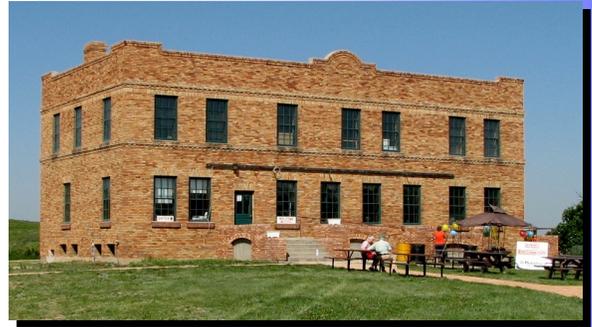
**Former Bunk House / Heritage Visitor Centre**  
*The refurbished 80-year old windows will, with proper maintenance, last for many decades.*

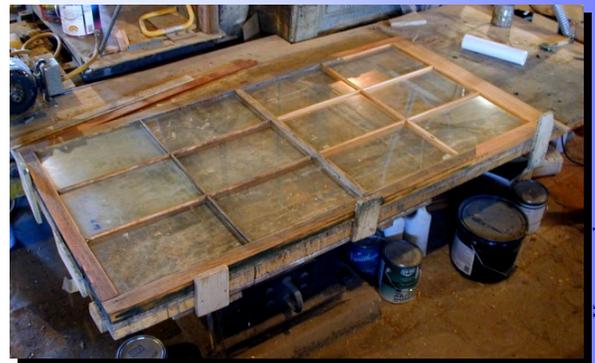
**Claybank Brick Plant National Historic Site**  
**Former Bunk House, near Avonlea SK**

*Salvaged old-growth wood as well as the original historic glass is used to repair this 1920 window at the Claybank Brick Plant. Installed in 1920, the wood windows in the Bunk House deteriorated significantly while the building stood abandoned for over 30 years. By 1997, when restoration was initiated, many of the windows were broken and falling apart.*

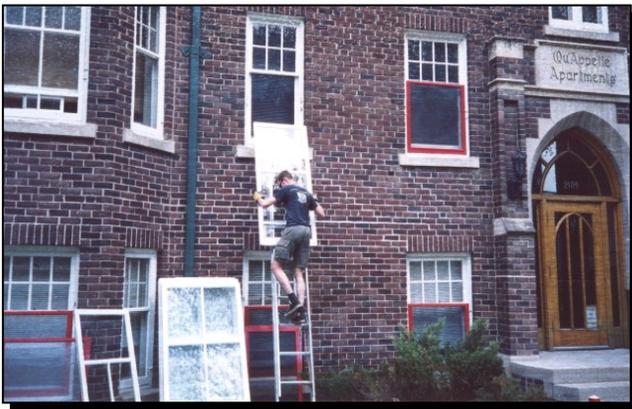
***Qu'Appelle Apartments, Regina SK***

*Regular maintenance requires a lot of work and may also be costly, but is a key factor to retaining the historic character of a building.*

Regular maintenance is labour intensive and includes replacing deteriorated putty, scraping, and/or sanding peeling, blistering or alligator paint finishes, repainting the wood on a regular basis, and replacing broken window panes. It also requires the hardware to be kept clean and not compromised by painting the windows shut. This may require removal of previous coats of paint to avoid the build-up of successive layers of paint that impedes the smooth up and down movement of double-hung windows or the proper closure of casement units.

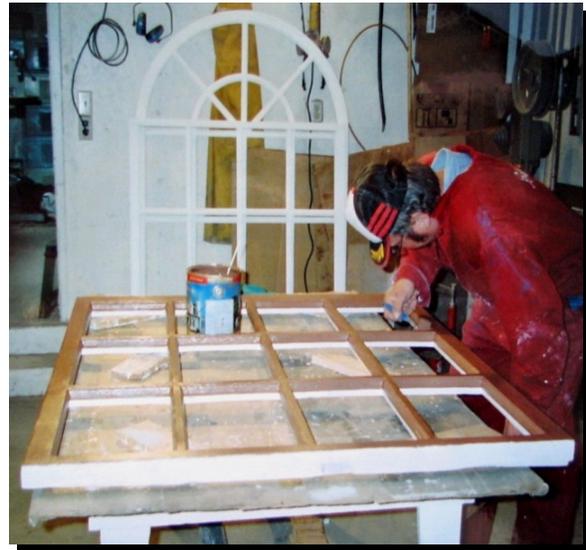
*Holy Rosary RC Church, Grass Lake RM #381 SK*

*A qualified local carpenter repairs historic windows damaged by a severe hail storm.*

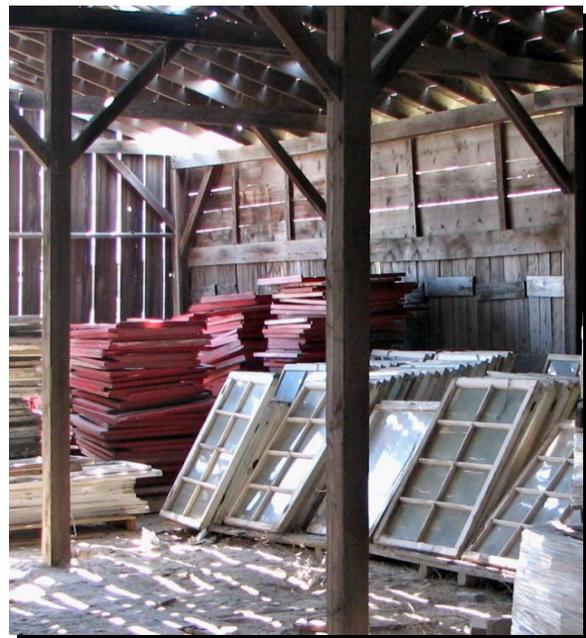
*Claybank Brick Plant*

*Salvaged historic windows are stockpiled to repair the many broken windows in the complex.*

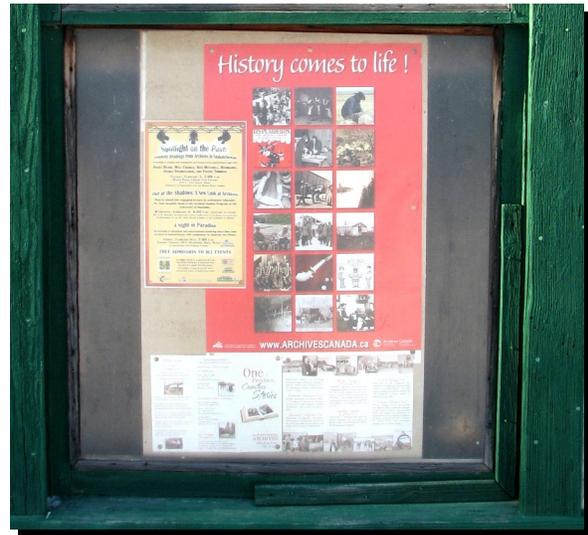
**Former Dollar Land Co. Office , Truax SK**  
*The Lexan in this window is so pitted and yellowed that it is difficult to read the display.*

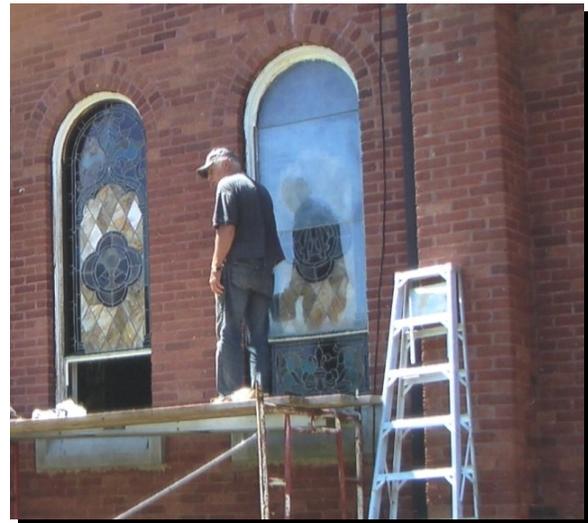
**Marysburg RC Church, SK**  
*A Lexan storm window will protect the stained glass from breakage caused by rocks, hail, and birds, but has a major visual impact on the building. Although Lexan is clear and very reflective when first installed, it will pit and become almost opaque within a decade.*

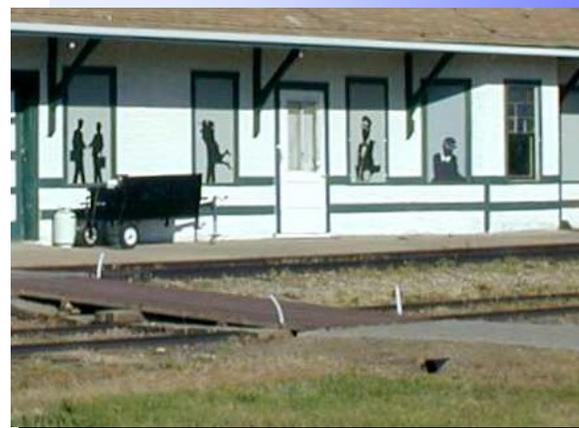
**Radville, SK**

*Silhouettes grace the plywood-covered windows at the former railway station.*

At Radville, silhouettes of people inside the building enhance a version of this technique, and reflect their various functions as railway employees or passengers.

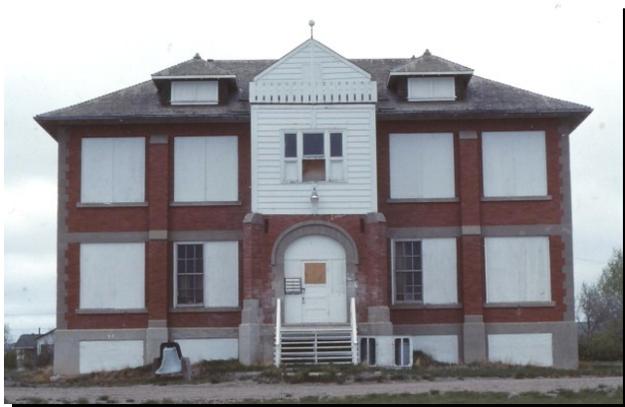
**Alsask, SK**

*The plywood covers over the door and windows protect the interior, but are extremely unattractive and send a clear message to potential vandals that this former school is now vacant.*

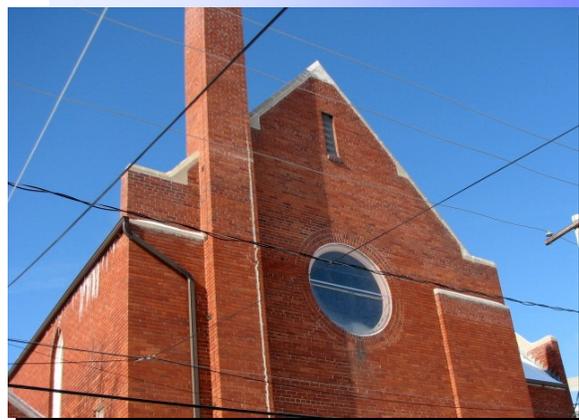
**Regina, SK**

*Due to extensive vandalism, bullet-proof glass was installed to prevent further damage to the stained glass rose window.*

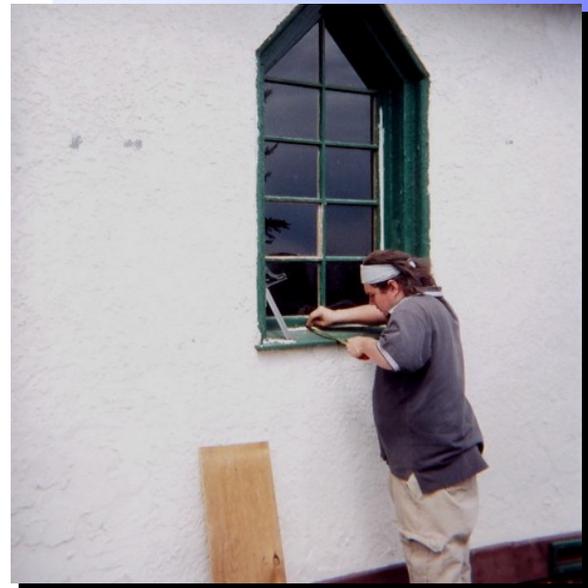
### **Key First Nation, near Veregin SK**

*First Nations carpenters helped repair and selectively replace rotten wood sills at this church.*

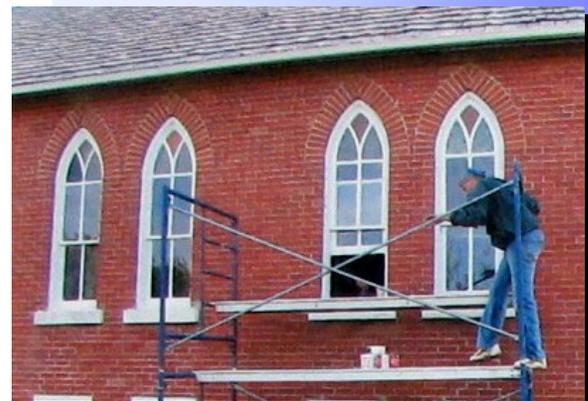
### **Emmanuel Lutheran Church, RM of Lumsden SK**

*Local contractors repair church storm windows.*
