Saskatchewan Heritage Foundation
CONSERVATION BULLETIN SERIES

Base

Base - This Conservation Bulletin is a resource guide for some of the most common foundation issues found in Saskatchewan heritage structures.

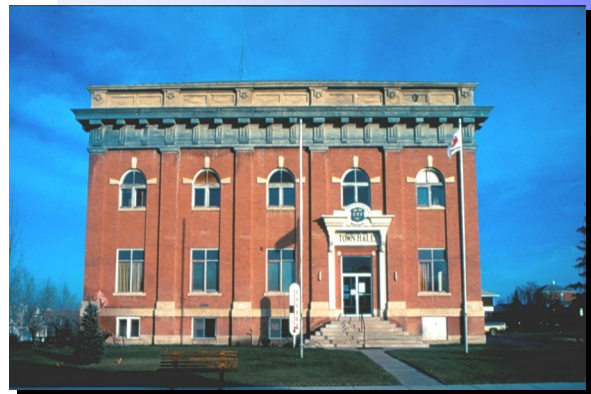
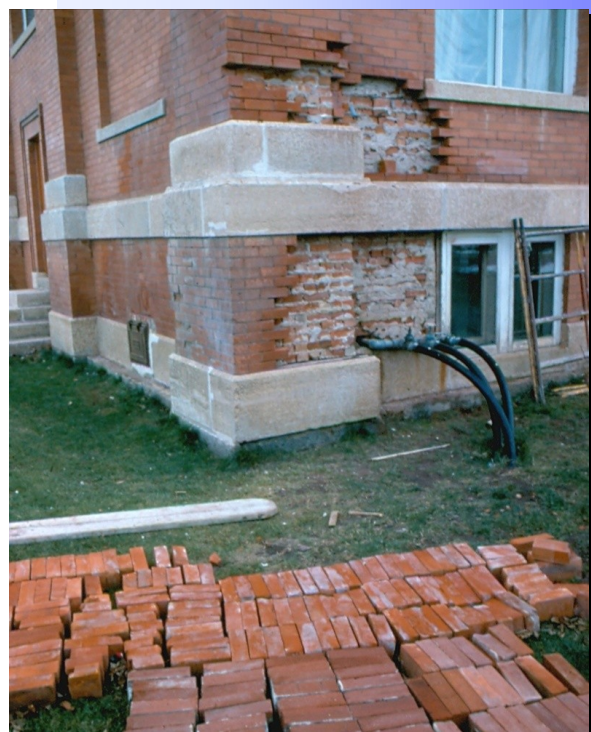
Town Hall / Opera House, Battleford SK

Battleford Town Hall / Opera House (1912) Water leakage at the top of the wall was a contributing cause to damage visible at the base of the building. <http://www.battleford.ca/buildings.html#thoh>

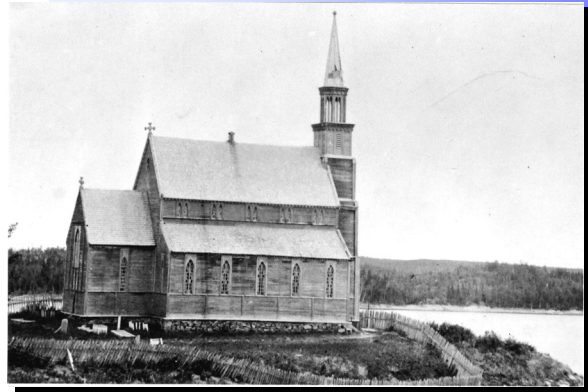
Holy Trinity Anglican Church, Stanley Mission SK
(1854-1860)

This late nineteenth century archival photograph shows the church on its the original stone foundation. As decades passed, the foundation began moving with shifting soil conditions and the heavy post and sill construction of the wall structure was deteriorating due to rising damp.

It is desirable to augment and retain original load bearing masonry or stone foundations, but this is not always possible due to a variety of site conditions including soil composition, site drainage characteristics, and load bearing requirements. At Stanley Mission's Holy Trinity Church (1854-1860), for example, the original stone foundation was replaced with a combined stone and cement foundation to provide an above-grade appearance compatible with the historic structure while increasing stability in areas not visible and below-grade for greater long-term stability.

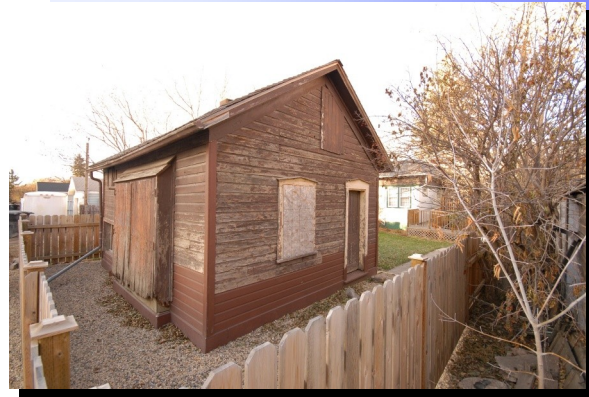
Trounce Residence / Fehr

Trounce Residence (1883) is the oldest existing building in Saskatoon.
http://www.saskatoonheritage.ca/designated/trounce_house.html

While historic buildings often settle over time, raising the grade level around a building through the addition of extra soil or organic materials can also give the appearance of the structure sinking further into the ground. Building settlement combined with an elevated site at the Trounce Residence in Saskatoon allowed water to potentially flow into the building or seep into the lower structure and cause water-related deterioration. The site has now been appropriately graded and drained.

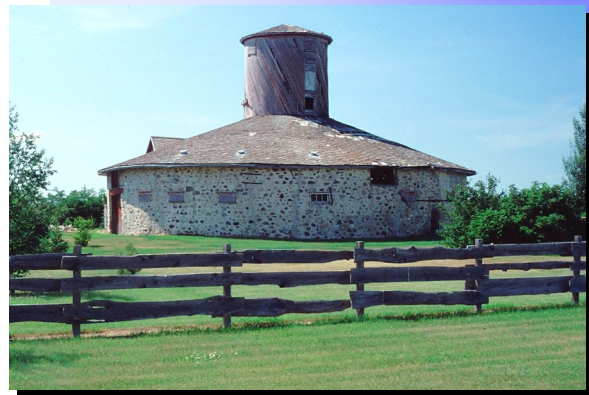
Bell Farm / Bruce Neill

Bell Farm (1882), Indian Head SK - no longer used as a horse barn, the altered temperature and humidity levels combined with poor maintenance to enable cold penetration and deterioration of the structure to the point where it was unsound. Fortunately, the community has rebuilt the structure with improved foundation, wall and roof systems.
<http://www.bellbarn.ca/history.php>

The Bell Farm barn (opposite) in Indian Head represents a type of historic structure that, as a result of time, history and the changing nature of the farming economy, was left unused. This impacted foundation conditions.

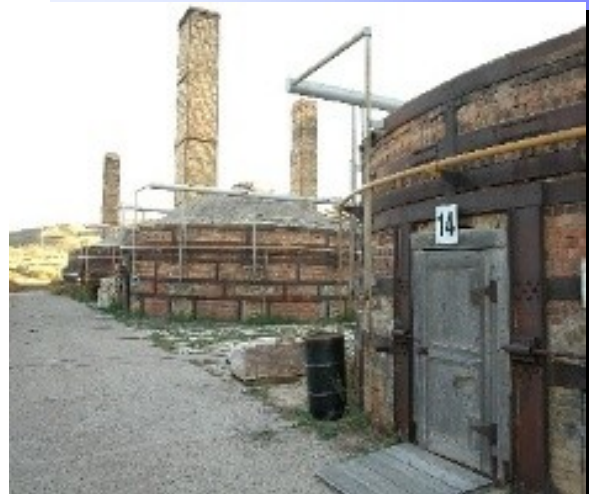
Claybank Brick Plant / Korvenaker

Claybank Brick Plant, (1912) near Avonlea SK - The kilns are no longer used and the soil around the kilns has cooled; this has combined with exceptionally high ground water levels to result in increased dampness and efflorescence on the kilns' brick wall.
<http://www.tpcs.gov.sk.ca/Claybank>

Foundation damage might be the result of material failure due to a weak or deteriorated cement mix or inadequate design; but damage can also result from many other factors such as: inadequate site drainage, soil settlement, a high water table, tree roots, poor eave trough maintenance that concentrates water saturation, soil conditions, or unrelated activity adjacent to the site which is causing vibration and settlement. Additional causes of foundation deterioration could also include: subsurface ground movement, rising damp, improper site grading, fungal rot, condensation due to poor ventilation, insect and vermin infestations, and the proximity of vegetation and related irrigation systems to foundations. Changes to a structure's surroundings or function can also result in negative impacts on foundations. For example, a change of the type of occupancy could result in increased loads, new openings in the structure, interior climate change that might alter normal moisture content levels. Although many Saskatchewan heritage buildings have been continuously occupied, a change of use has impacted a variety of historic structures that have undergone dormant periods where they have remained unheated and poorly maintained especially during the winter. The beehive shaped kilns at the Claybank Brick Plant National Historic Site near Avonlea provide an example of the impact of a change of use. Once an industrial site where the kilns were regularly heated to extreme temperatures during the brick manufacturing process, the site is now a tourist attraction. The kilns are no longer used and the soil around the kilns has cooled; this has combined with exceptionally high ground water levels to result in increased dampness and efflorescence on the kilns' brick walls.

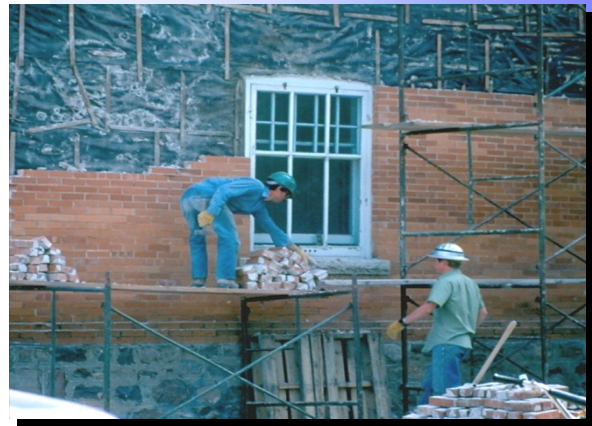
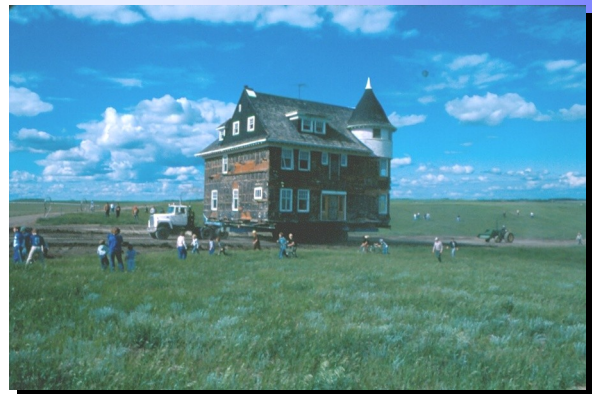
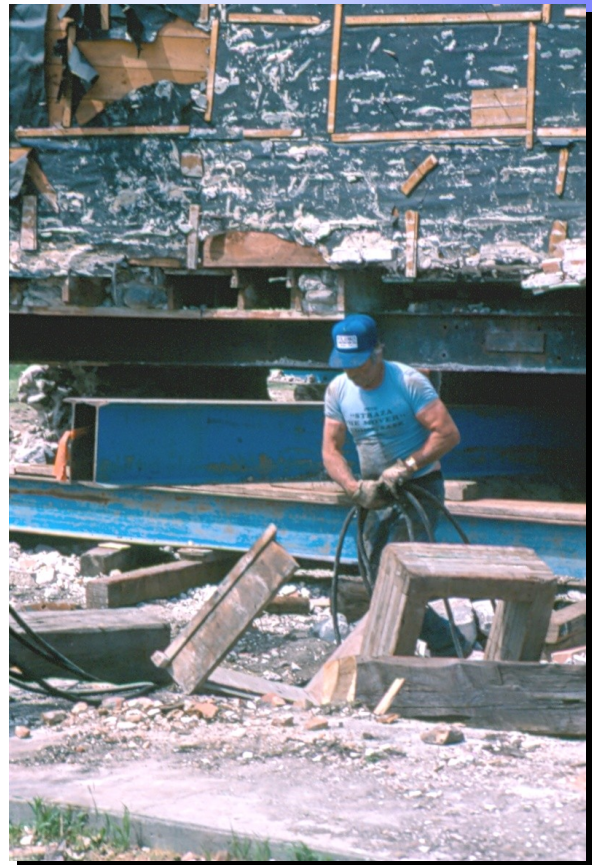
Banbury Residence, Wolseley SK (1905) built by Edwin Banbury, founder of the Beaver Lumber Company. The brick wall facing was removed prior to relocation of the building across town. The brick was then reapplied and the building restored for use as a restaurant and inn.
<http://www.banburyhouse.com/>

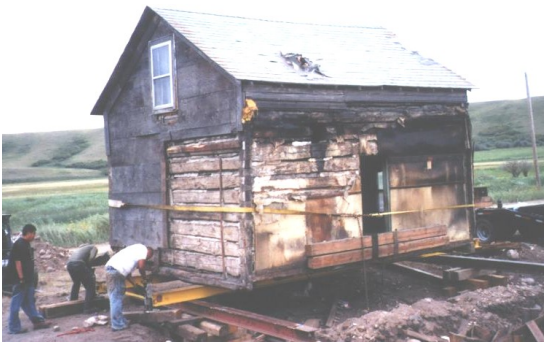
E*nsuring that a foundation rises above grade level* to provide clearance between ground cover and the wall structure is an issue sometimes faced in historic buildings, especially smaller structures without basements or crawl spaces. Historic log houses at grade level or on low foundations are also subject to deterioration as noted in the Edwards Log Home (pictured) originally located in the

Arm River Valley near Findlater, Saskatchewan. Because the house was built on grade, all bottom logs rotted and required replacement due to water damage.
