CONSERVATION BULLETIN SERIES

Brick Masonry

Brick Masonry - This Conservation Bulletin is a resource guide for some of the most common issues surrounding brick masonry on Saskatchewan heritage structures. It provides information to anyone considering the repair of historic brick masonry.

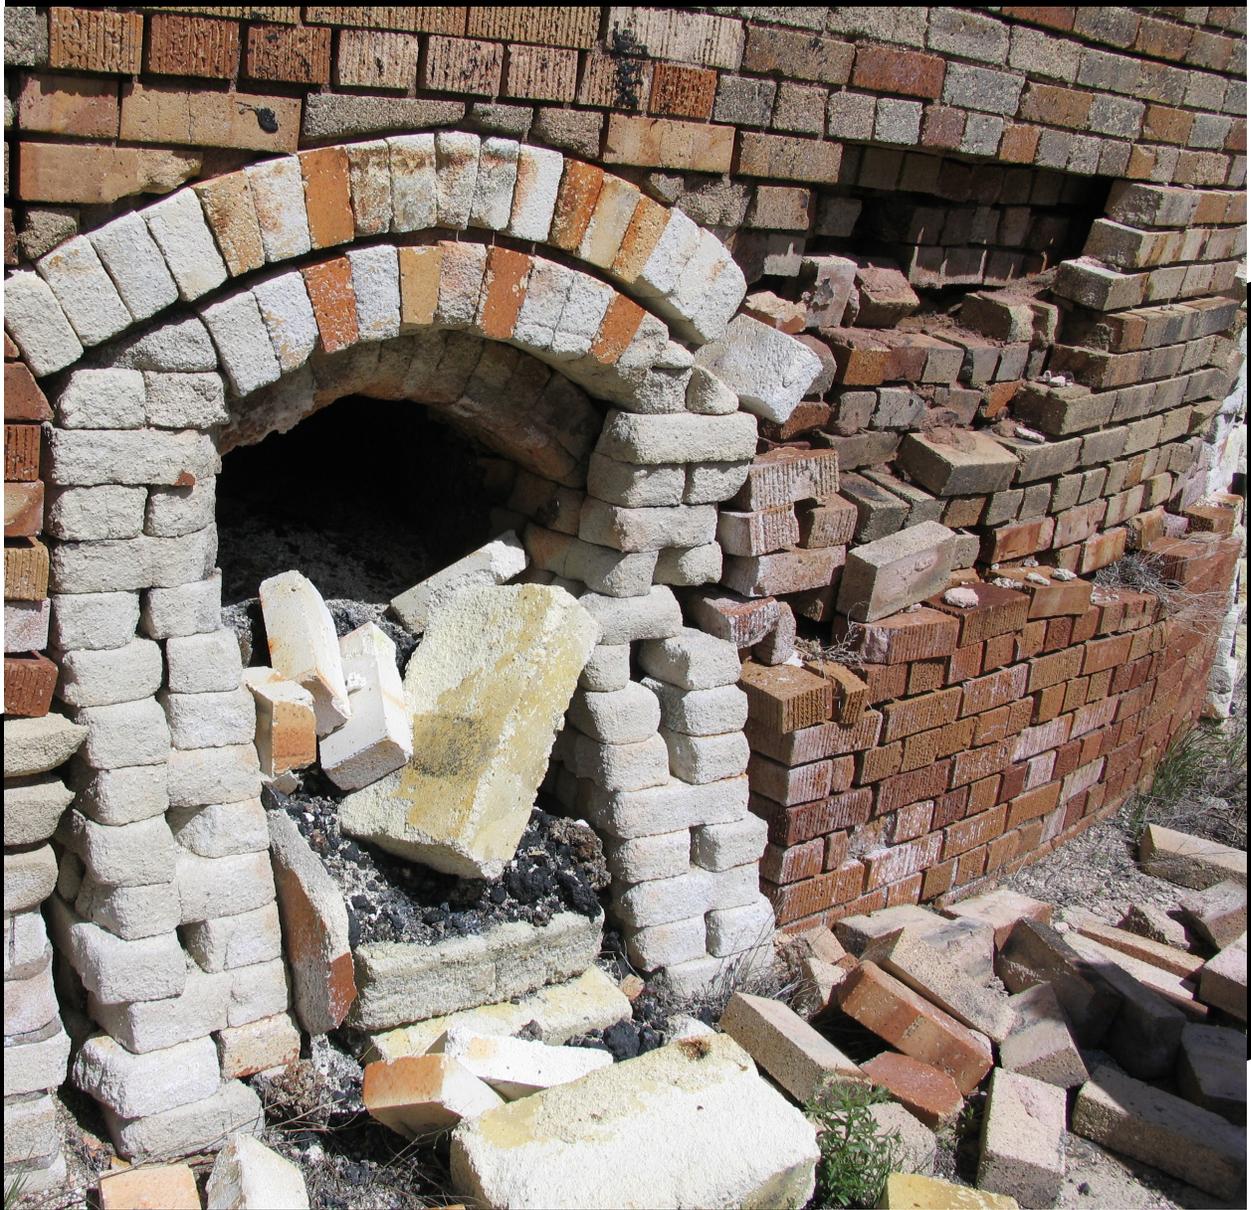
Cover Photo - DESTABILIZED EXTERNAL WALL, CLAYBANK BRICK PLANT/M.G. Miller

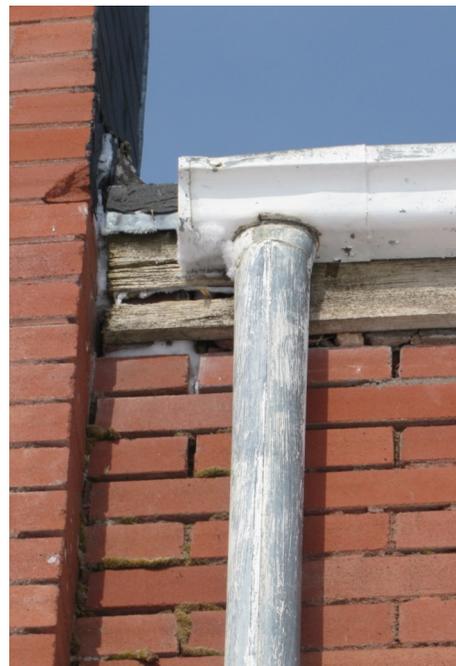
Fig. 6—Masonry damage at a common point of failure at the Khedive Recreation Centre, Khedive.

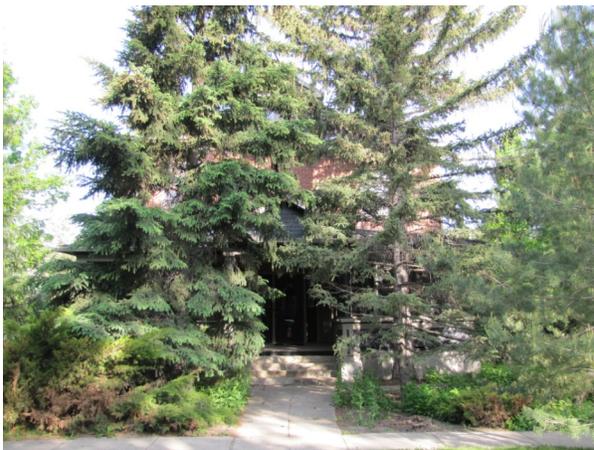
Fig. 12—Residence in Maple Creek showing trees close to the foundation.

Phosphates can also be introduced in masonry by fertilizer or plantings near the foundation.

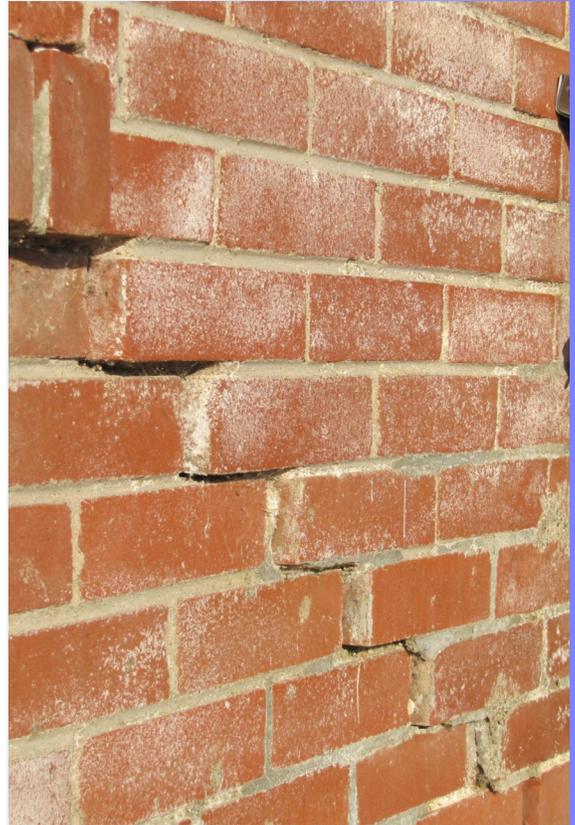
Fig. 13—A masonry wall shifts out of plane at the Veteran’s Memorial Hall in Earl Grey.

Slight bulging or shifting out of plane in a portion of a masonry wall often indicates that the brick or stone masonry surface veneer is separating from the rest of the wall. This may be because water is entering at a crack or joint, dissolving mortar, rusting ties, or freezing and moving brick or stone outward.

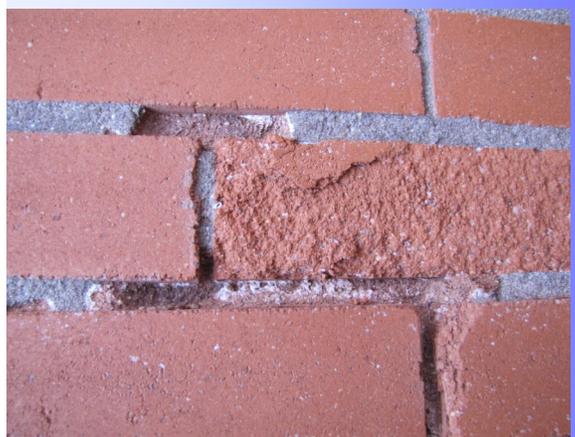
Fig. 14—Spalled masonry unit at Khedive Recreation Centre, Khedive.

Spalling of brick often reflects elevated levels of moisture in masonry but may also be caused by defects in the original masonry unit. An under-fired brick may spall while an adjacent brick remains sound under the same moisture conditions. In a typical Saskatchewan winter, high moisture content in masonry may lead to frost *spalling* or *jacking*, the fracturing of brick due to the freezing of water in porous masonry.

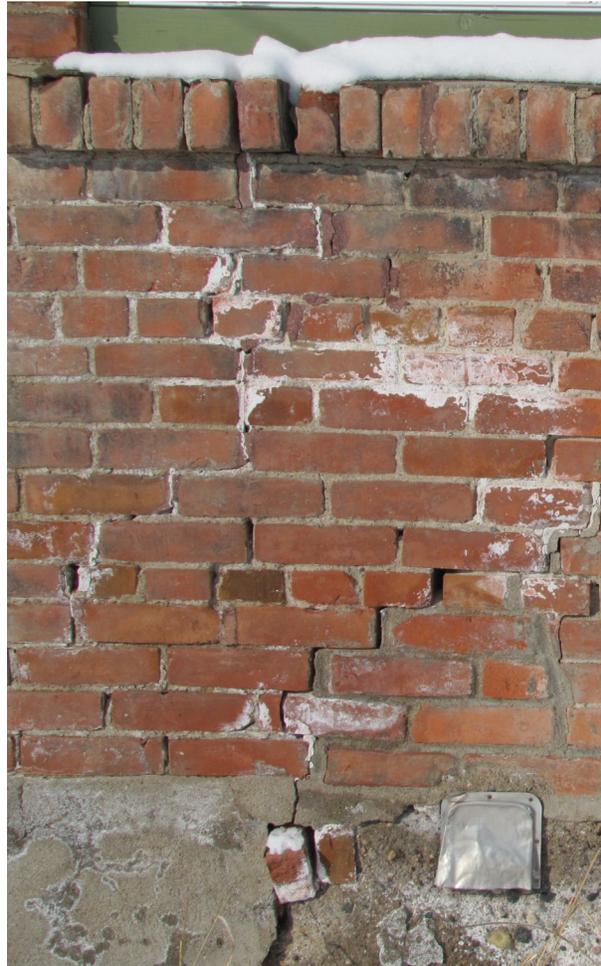
Fig. 15— Soiling and efflorescence at The Stoop, Rouleau

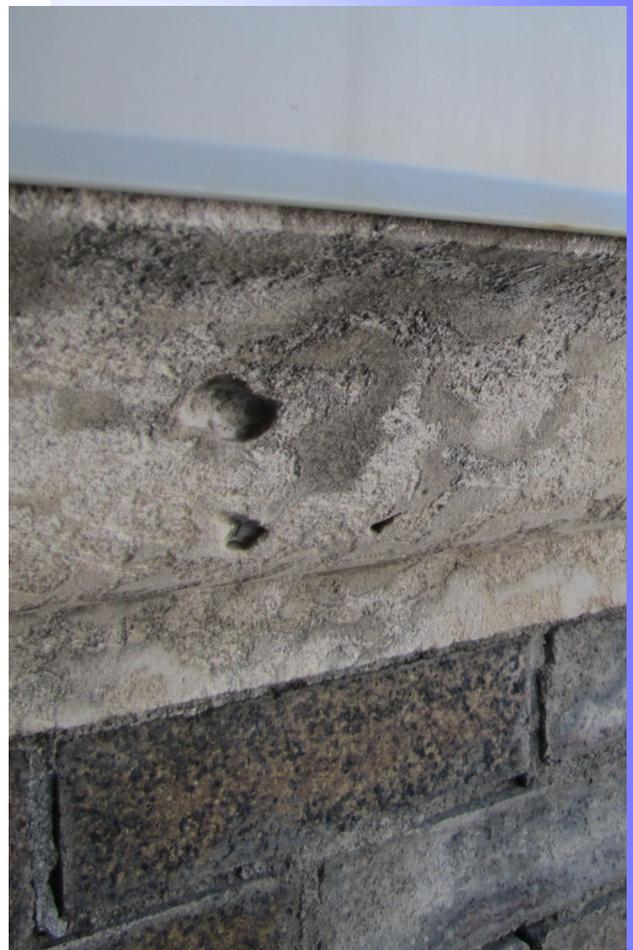
Fig. 16—Encrusted patina on the stone cornice at the former Land Titles Office in Moose Jaw.

The type of soiling that may be found at cornices such as that depicted below, need not be removed—this is called patina . Except for those situations where patina is causing moisture damage or reducing the structural integrity of historic fabric, it should be retained.

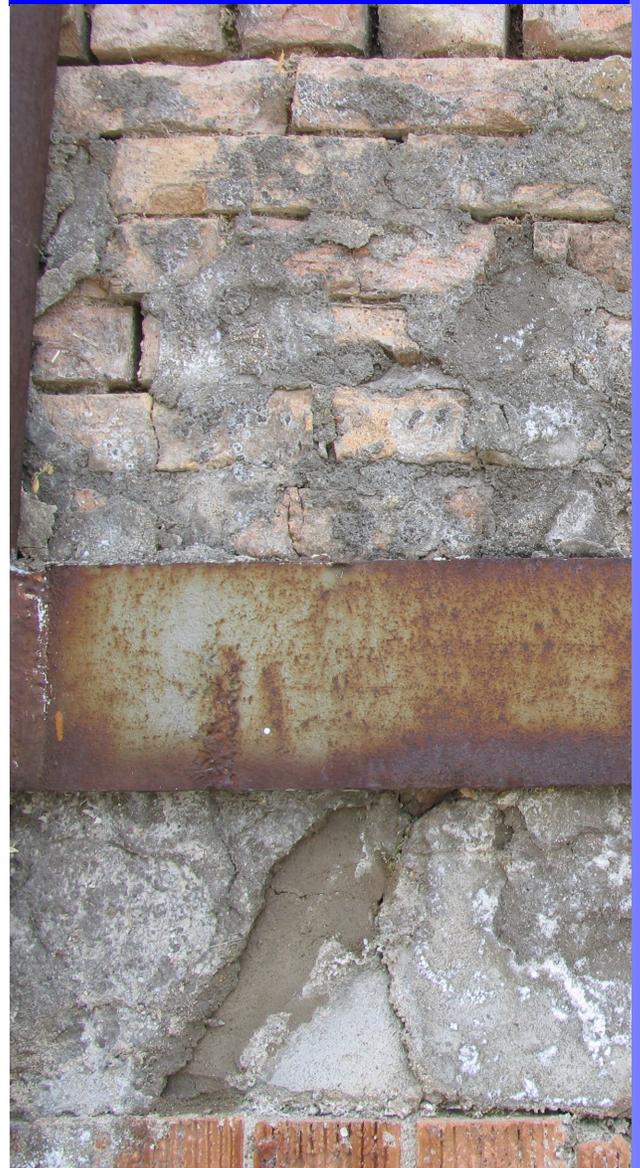
Fig. 18—Previous masonry repairs at a kiln at the Claybank Brickplant, National Historic Site.

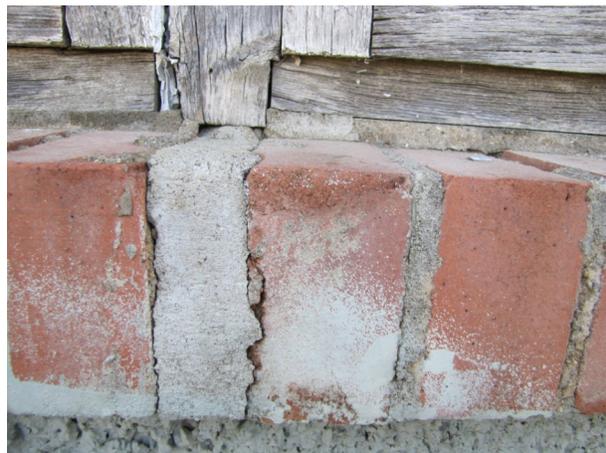
Fig. 19—Mortar joints at the Veteran's Memorial Hall in Earl Grey.

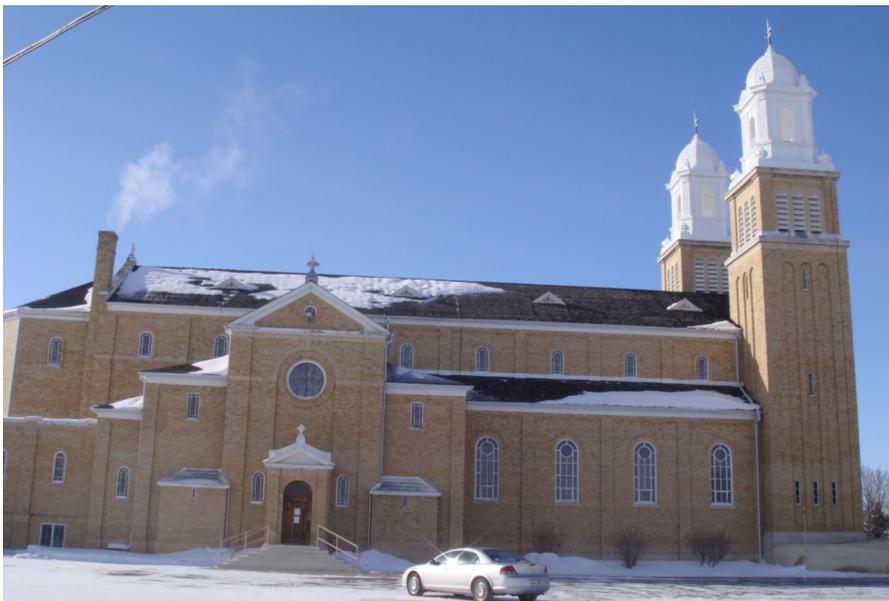
Fig. 21—The analysis of the historic mortar mix at the Co-Cathedral in Gravelbourg led to the selection of Type K mortar for its repointing.

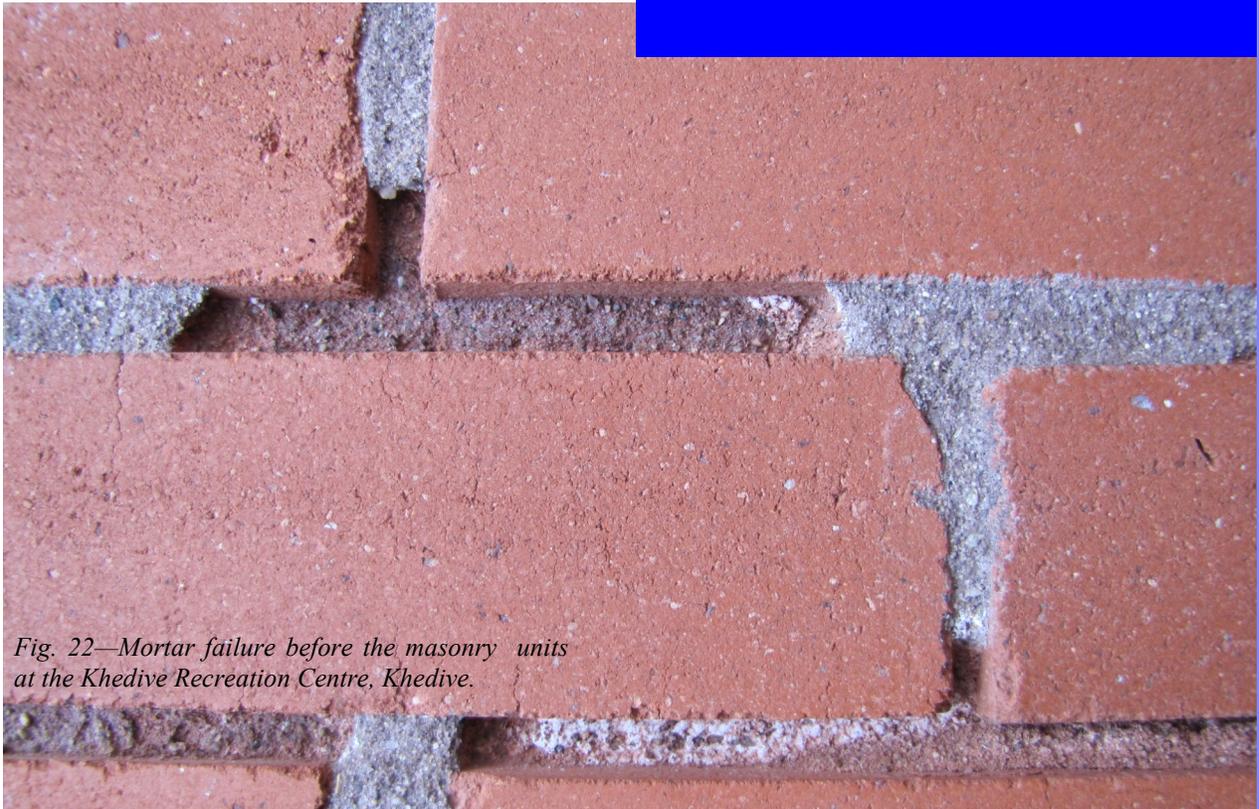
Fig. 22—Mortar failure before the masonry units at the Khedive Recreation Centre, Khedive.

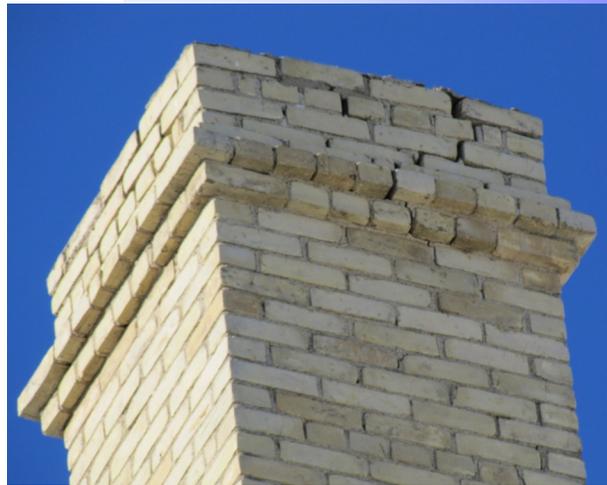
Fig. 28—Loose masonry at the Assumption Catholic Church in Holdfast.

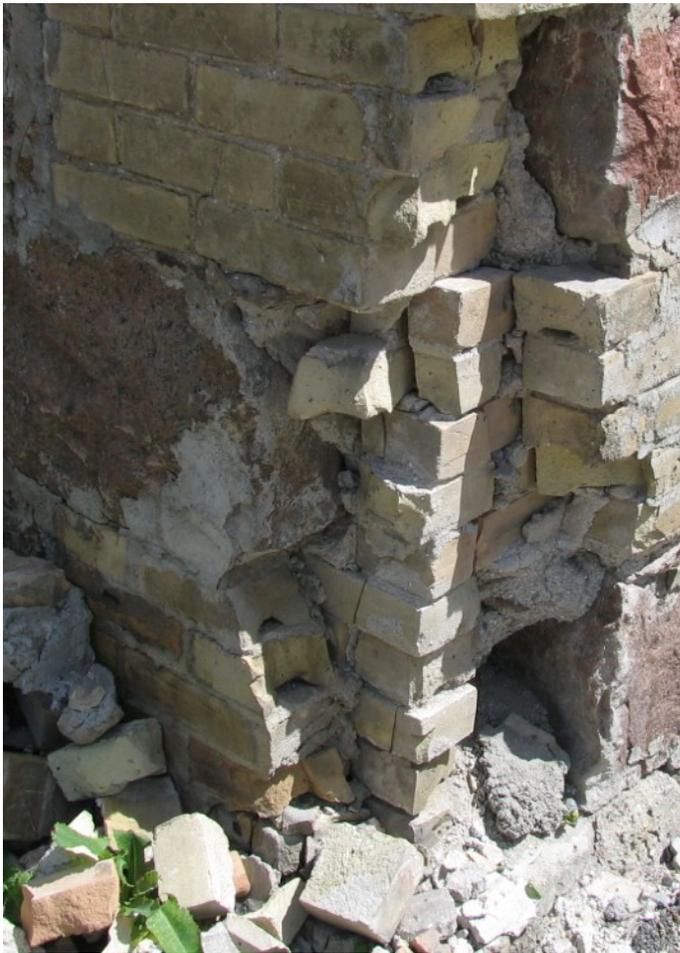
Fig. 29— Dislodged masonry at the 1886 McNaughton Stores in Moosomin.
